Device	XC886/888LM Series
Marking/Step	AC
Package	PG-TQFP-48/64

This Errata Sheet describes the deviations from the current user documentation. The module oriented classification and numbering system uses an ascending sequence over several derivatives, including already solved deviations. So gaps inside this enumeration can occur.

This Errata Sheet covers the following devices:

- XC886/888-6/8FF
- XC886/888LM-6/8FF

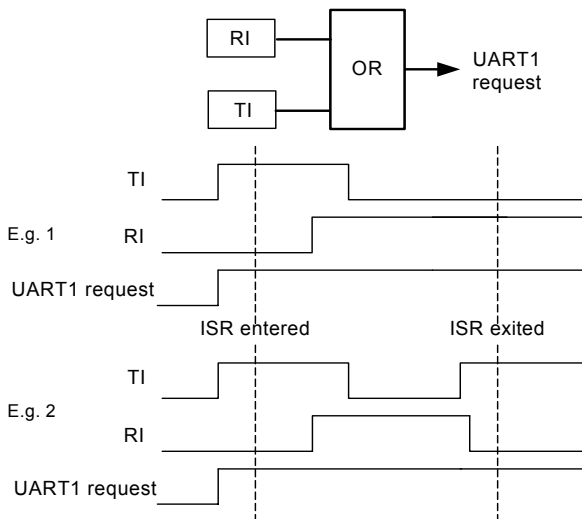
Figure 2

The problem is that it may occur at some point in the application, that any new UART1 interrupt request can no longer be detected after a return-from-interrupt (reti) due to service of earlier event(s). This happens when the following conditions are true:

1. UART1 events are serviced by interrupt (i.e. flags are checked and cleared only in the interrupt routine ISR),
2. Either RI or TI is set at any one time throughout the ISR (even while the other is cleared) such that at least one of the flags is still set after reti, causing the UART1 request line, which is an OR-function of the two flags RI and TI, to remain set throughout the ISR and after reti.

Two example scenerios are illustrated in the following figure:

This means, any future UART1 RI or TI event is not able to cause a rising edge and therefore not able to trigger an interrupt request to the core – as if the UART1 interrupts had been disabled, until both RI and TI flags are cleared at some time. The clearing of flags would have to be done by user's code

There are two suggested workaround:

1. If other events of interrupt node XINTR8 (EX2) need not be enabled for interrupt, disable this interrupt node and use software polling of the flags instead.
2. Before return from interrupt, check again if RI or TI is (still) set (due to new request since the last check). If so, jump and execute the ISR routine from start. Exit only when all flags are checked to be cleared. However, dummy interrupt of the node may occur after return from interrupt, and should be ignored. Another drawback is if UART1 events are occurring at high rate, the CPU may be 'stuck' in the service routine of the UART1 interrupt for a long time.

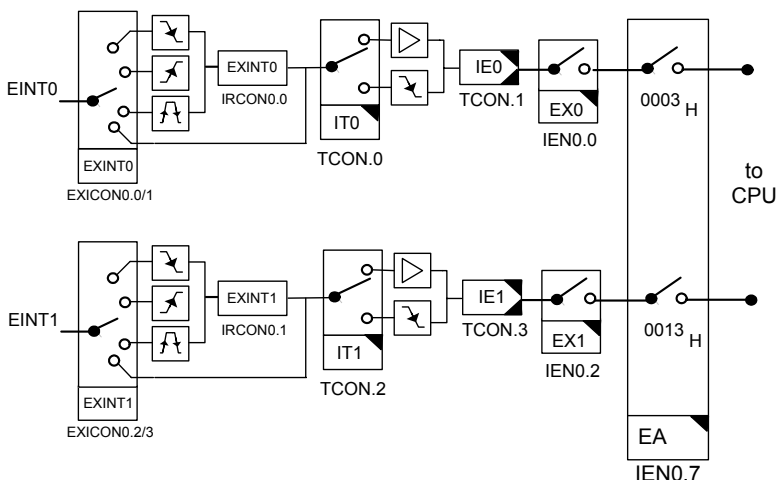
Figure 5

External interrupt 0 and 1 may individually be selected via respective bits (`EXINTx`) in `EXICON0` register, to request interrupt on falling edge, rising edge, both edges or to bypass the edge detection.

Edge detection is done in the system unit. If enabled, an active event will set the `EXINTx` flag and correspondingly set the `IEx` flag in `TCON`. It should be noted that after any external interrupt `x` event, flag `EXINTx` must be cleared. In case of falling edge as active event, this allows any future active event to be able to set the flag `IEx` as interrupt request. In case of low level as active event, this prevents unintended recurring triggering of interrupt request.
